SUNDAY RIVER WATERSHED ASSESSMENT AND PRELIMINARY RESTORATION STUDY

Final Report

Report No.: 2003-011
64 Pages, 6 Appendices

PREPARED BY
PARISH GEOMORPHIC LIMITED
AND
KLEINSCHMIDT

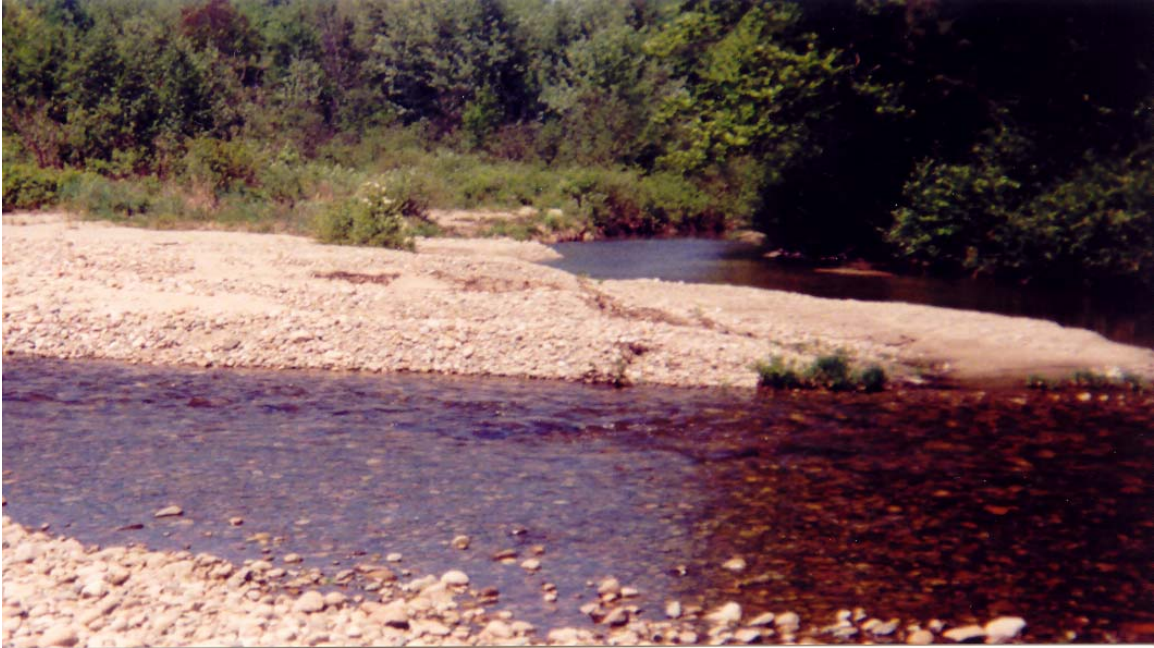
Reach SD-1. Note the large amounts of gravels and cobbles deposited in this area.

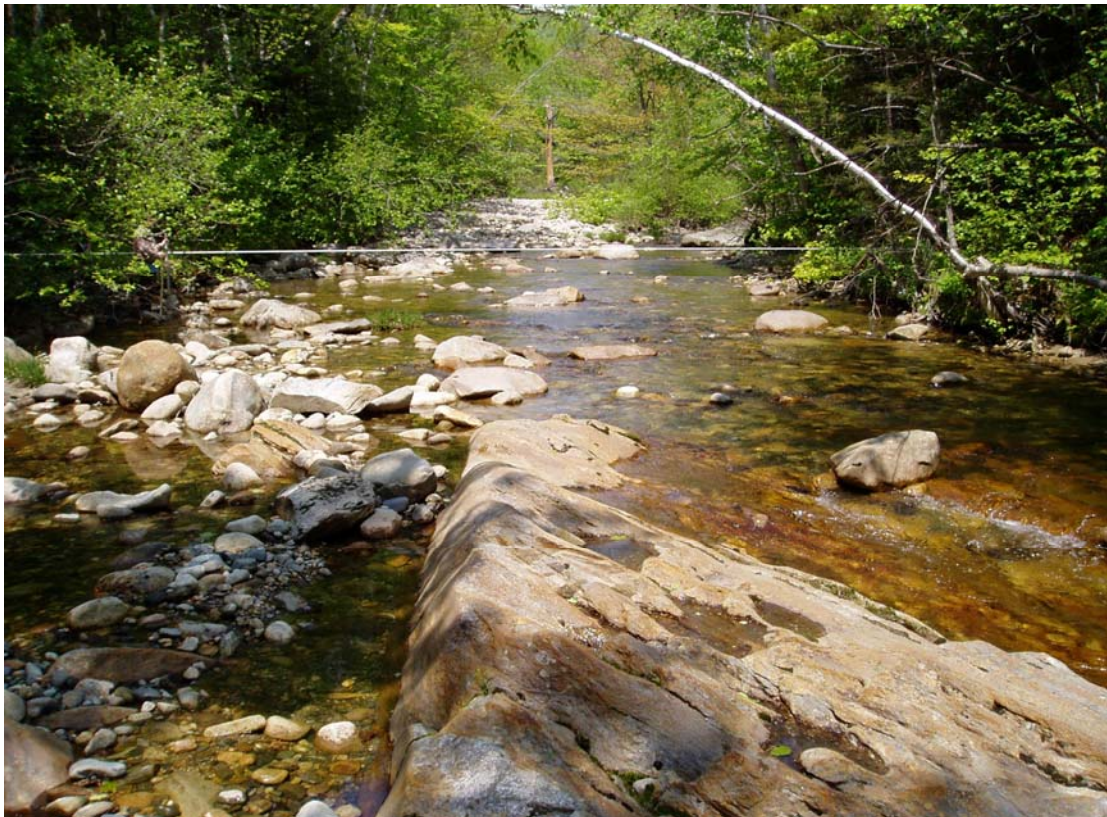
Reach SD-8. Monitoring site located upstream of the 'gated bridge'.

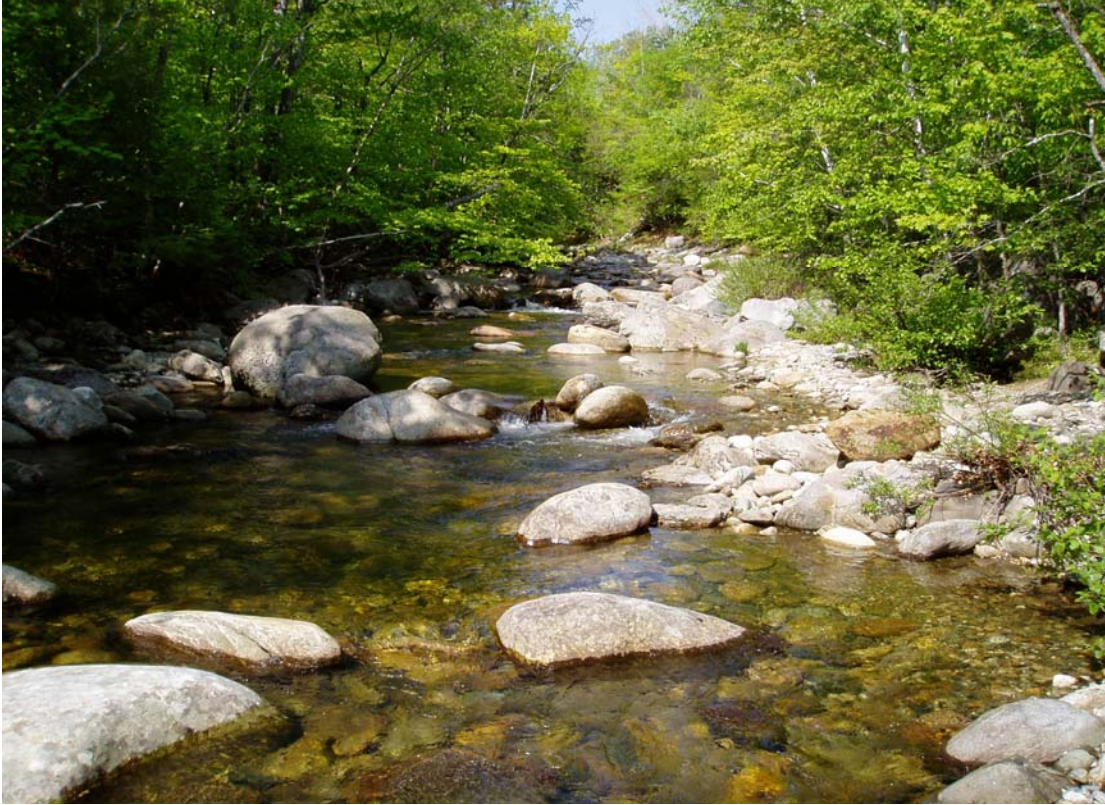
Reach SD-10. Furthest upstream monitoring station established, note large substrate and overhanging trees.

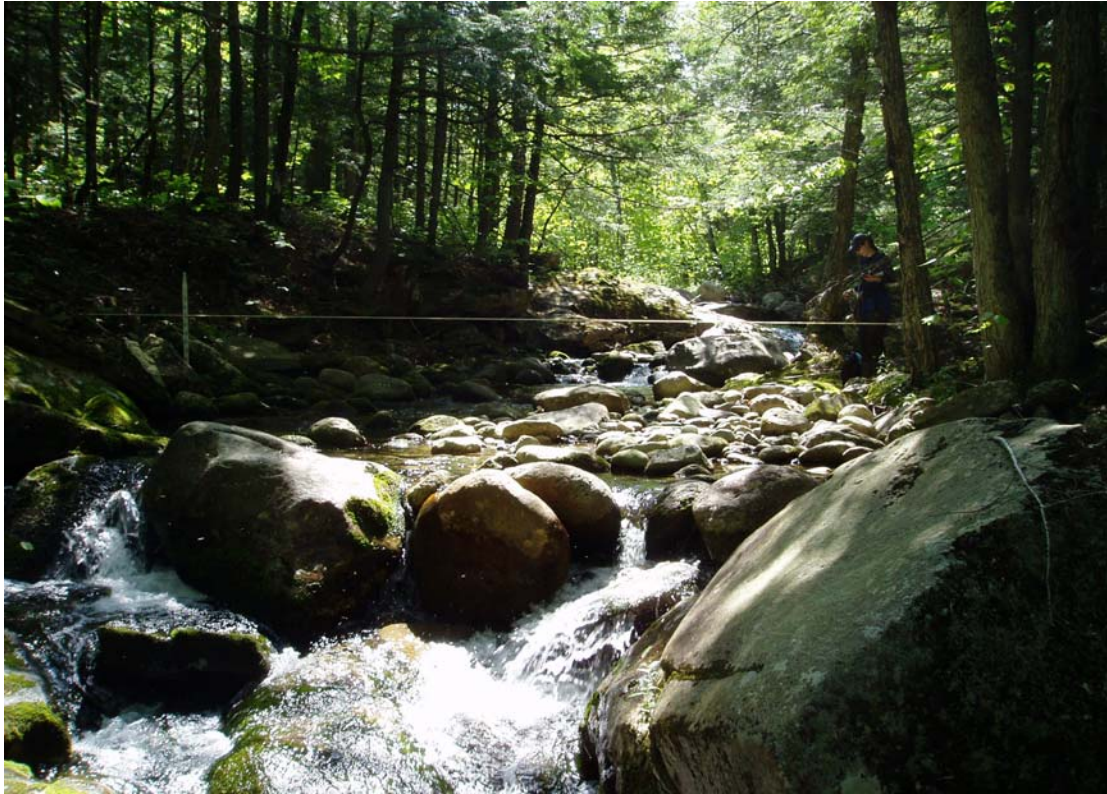
Reach SD-18. Monitoring site on Jordan Brook. Note the larger substrate and steep gradient.

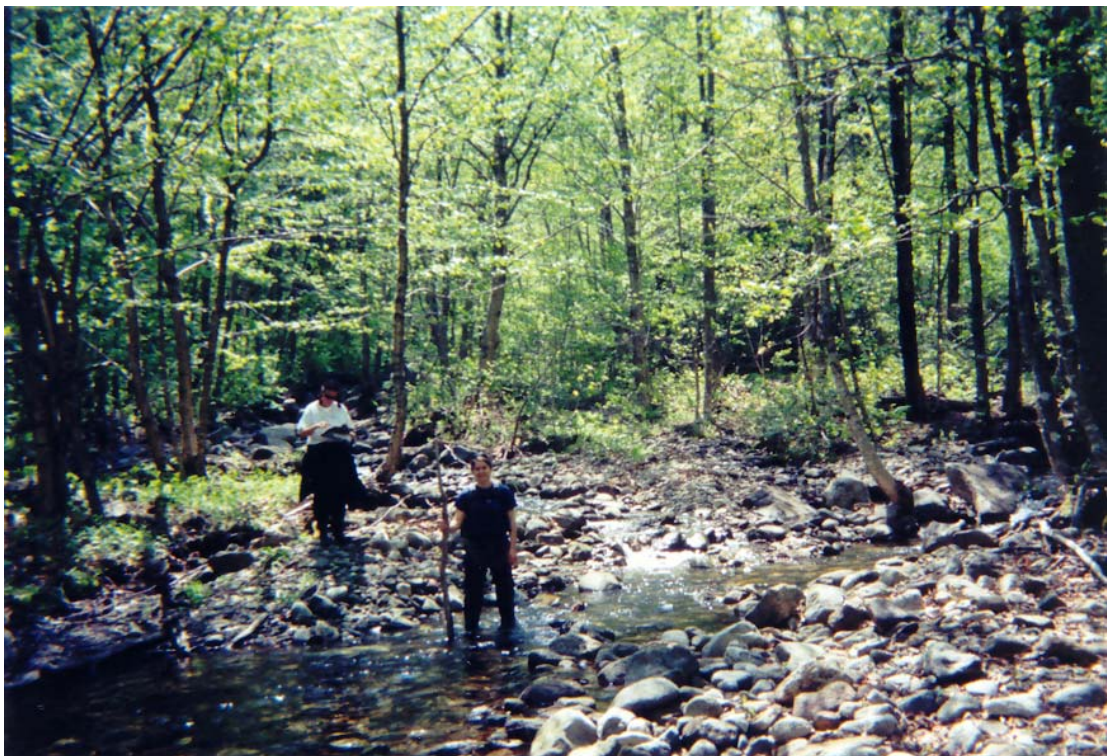
Reach SD-20. Upstream reach of Jordan Brook, note the small size of the channel and dense overhead canopy.

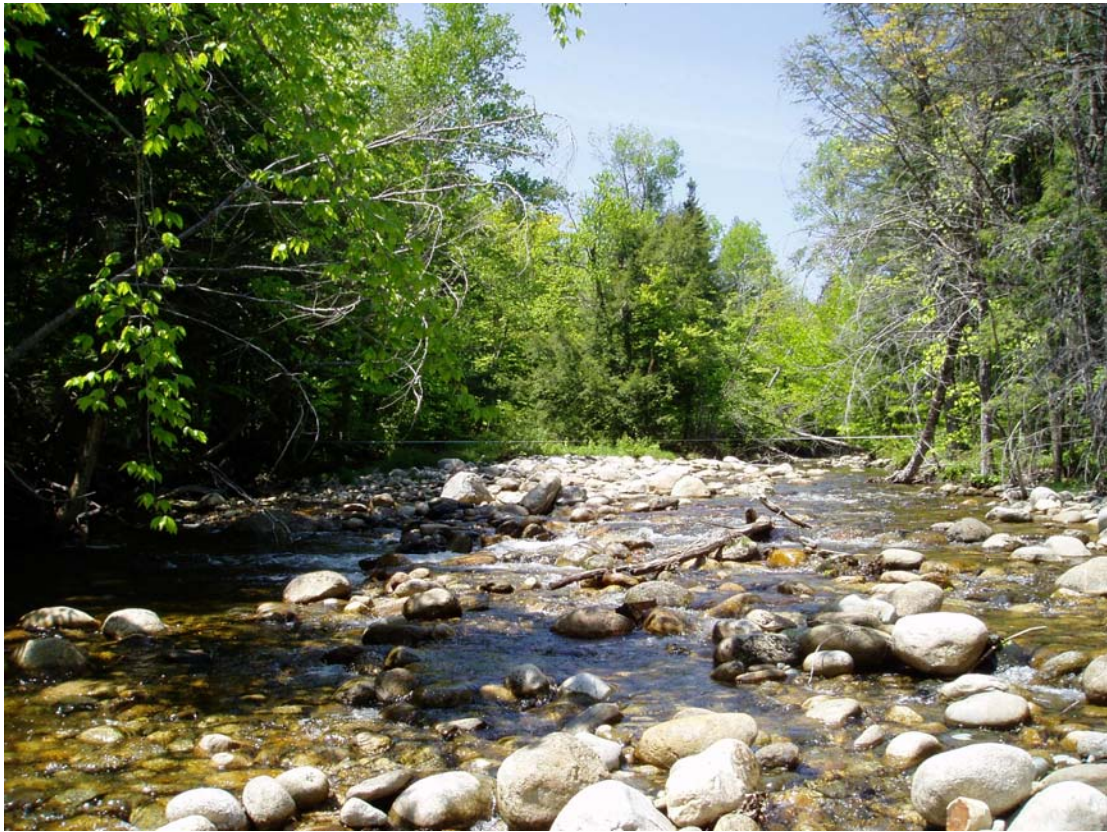
Reach SD-21. Monitoring site on Bull Branch. Note the coarseness of the substrate.

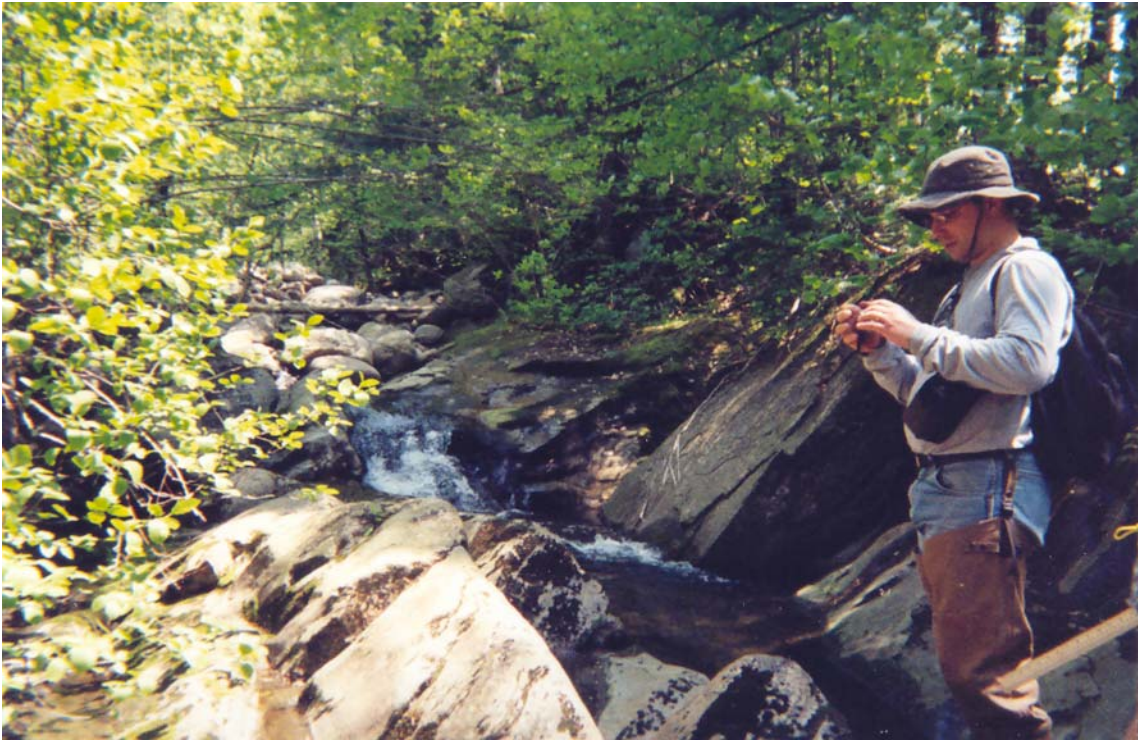
Reach SD-30. Upstream reach of Merrill Brook. Observe the extensive bedrock outcroppings.

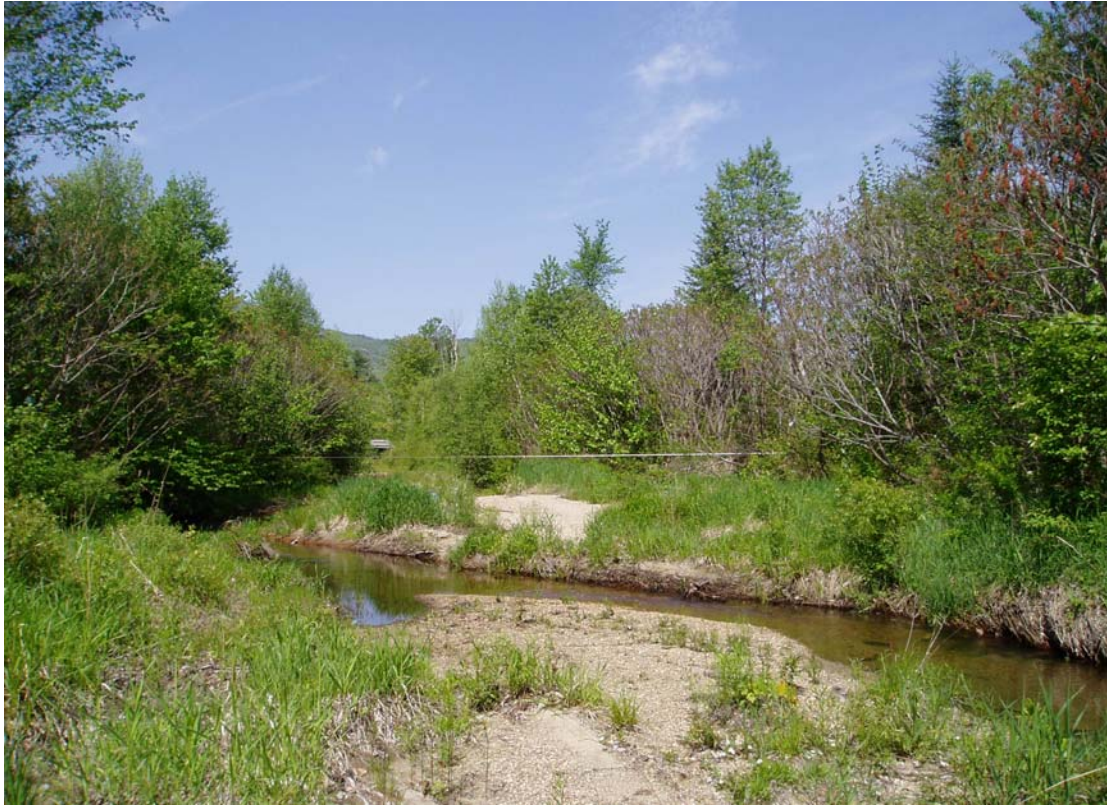
Reach SD-33. Monitoring Site established on Barker's Brook downstream of the Sunday River Road.

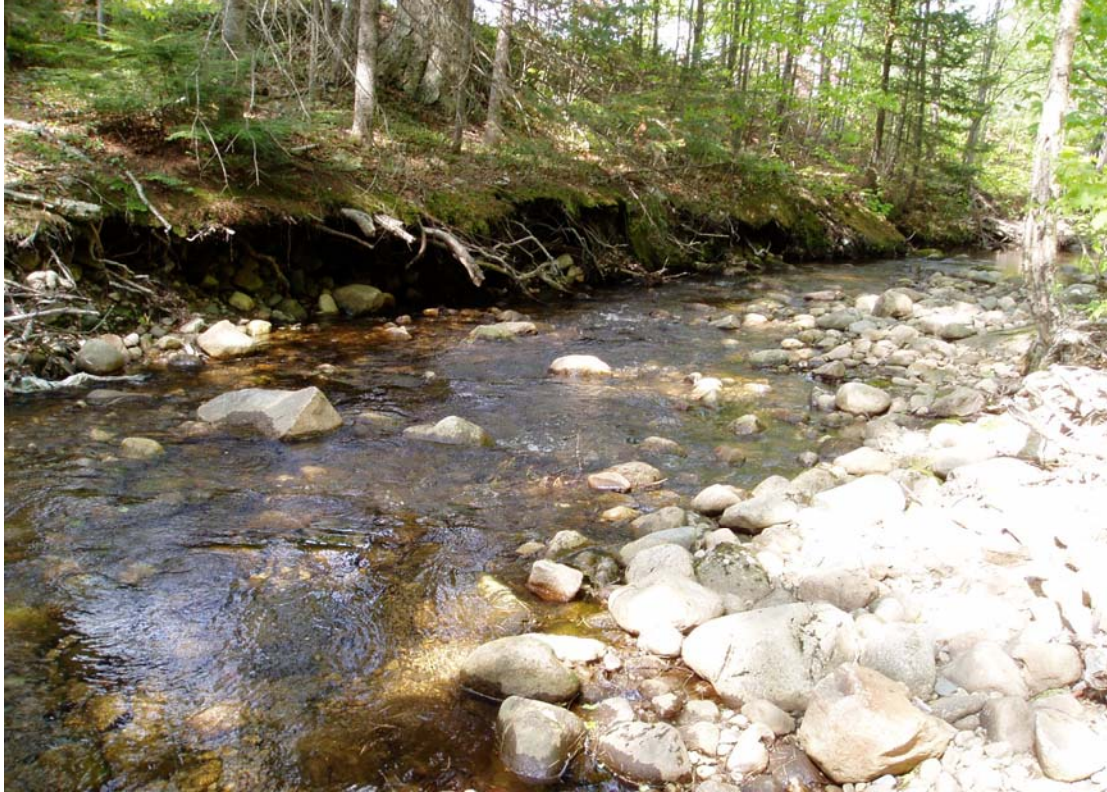
Reach SD-34. Barker's Brook upstream of Sunday River Road.

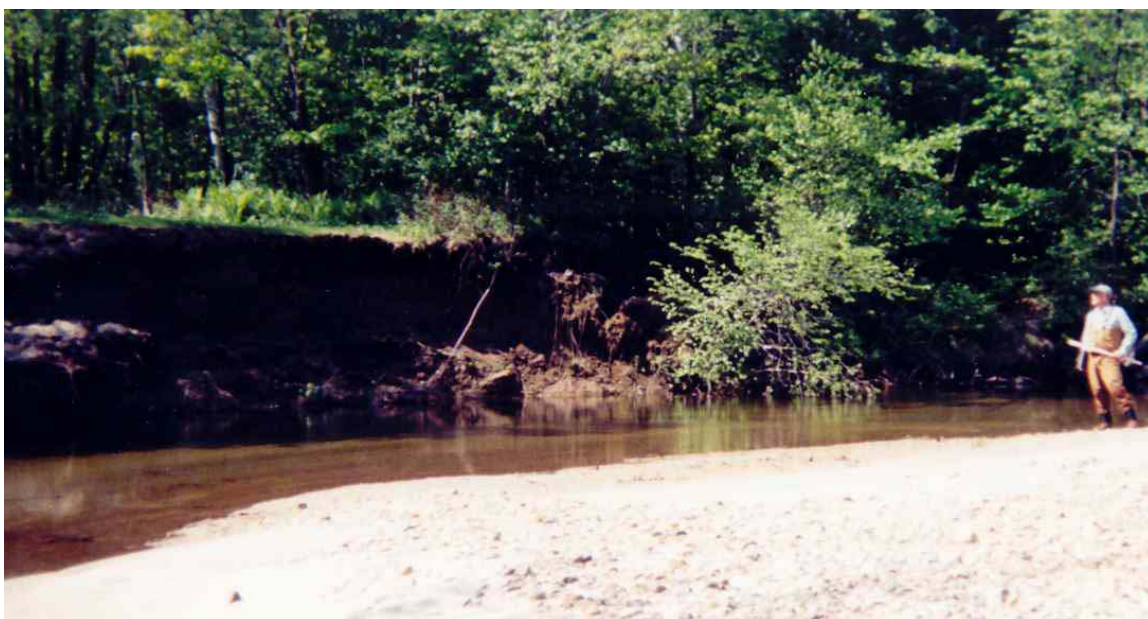
Photo 1. Area of bank erosion in Reach SD-2.

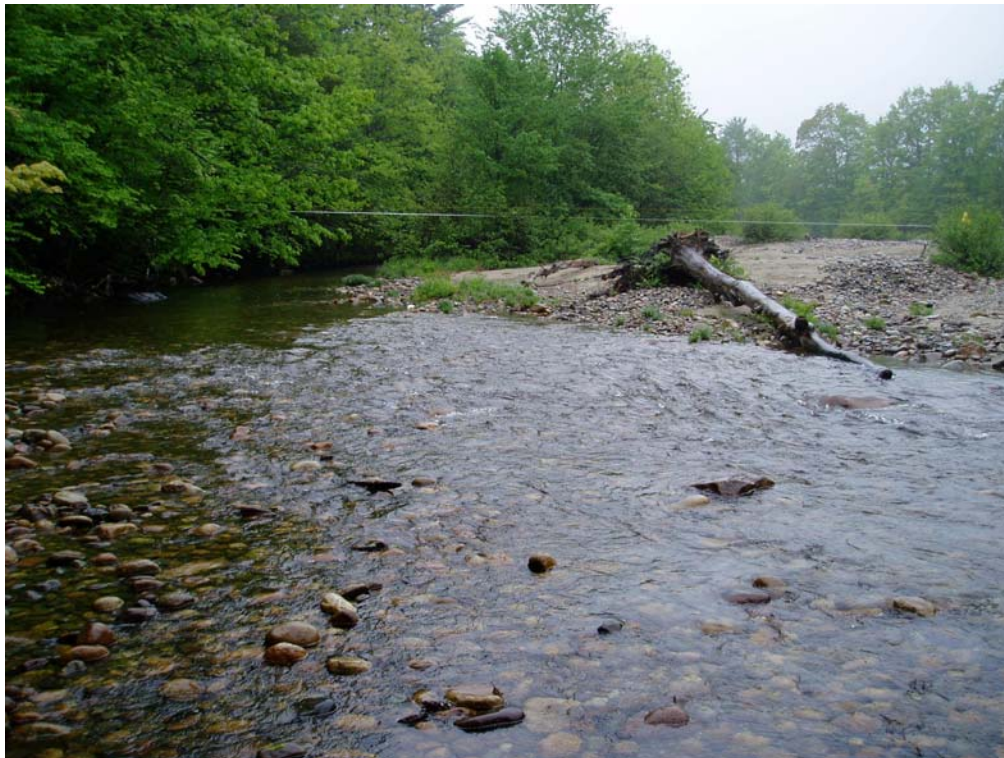
Photo 1. Right side of channel at monitoring site SD-3 (see Figure 2).

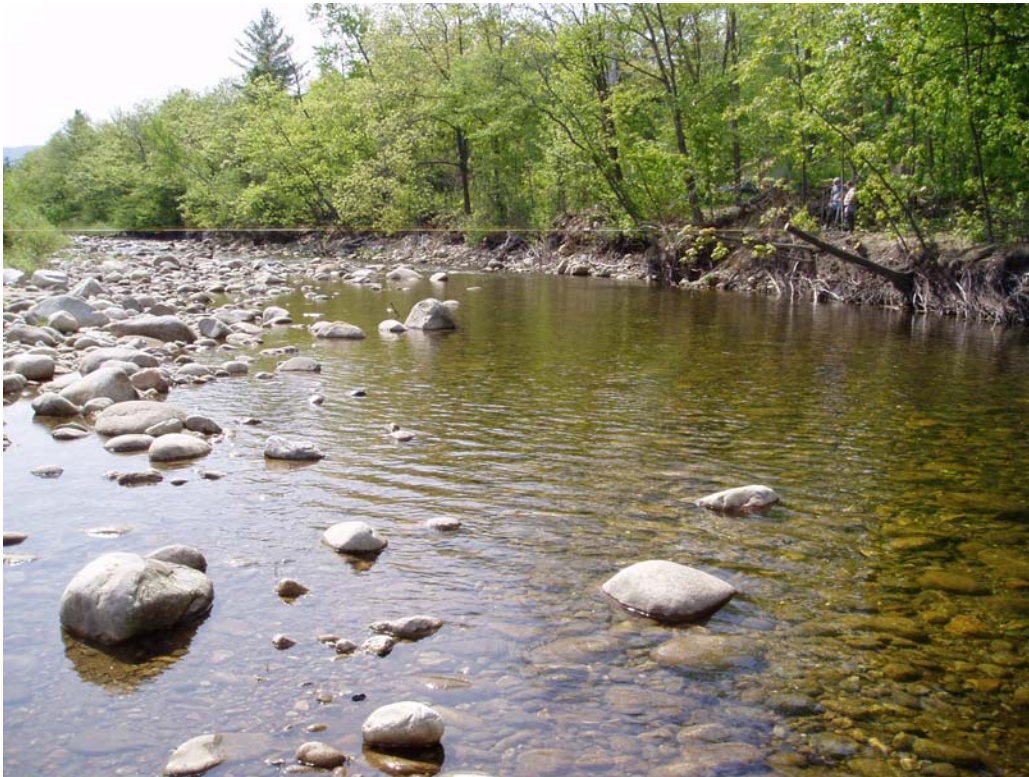
Photo 1. Sunday River at monitoring site in Reach SD-5 (Outward Bound).

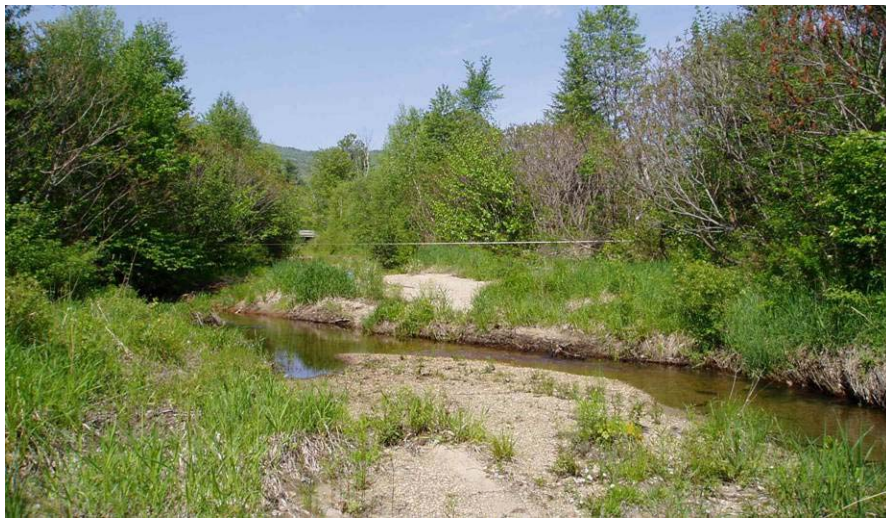
Photo 1. Monitoring site at SD-33 (see Figure 2).
